Errata

SLG46517

CE-GP-001

This document contains the known errata for SLG46517 and the recommended workarounds.

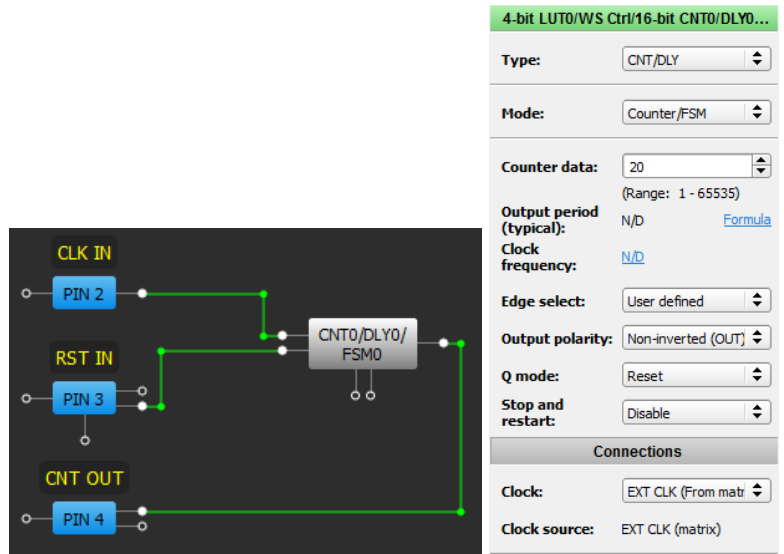
Figure 1

If the Counter Reset is asserted at the same time as a rising clock edge, it is possible that the Counter Data will be reset incorrectly and the counter output may appear faster than expected. This phenomenon appears more often as the clock frequency increases.

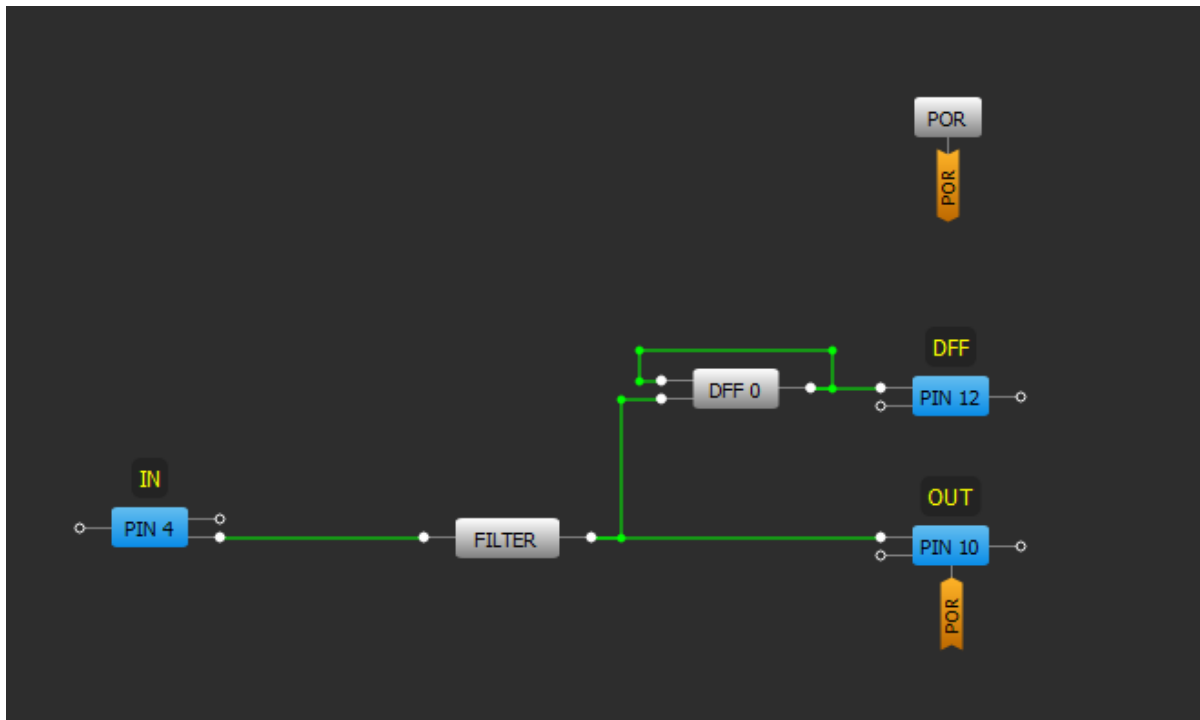
Figure 4

If clock type high frequency input comes in, the FILTER cell may not filter out it. There are several factors like input frequency, duty cycle and LOW duration in such signal that may lead to its passing through FILTER block.

Currently there is no workaround for this issue. Filter block is good at filtering short spontaneous glitches. It is intended to be used in series connection before the delay cell to avoid its latching.

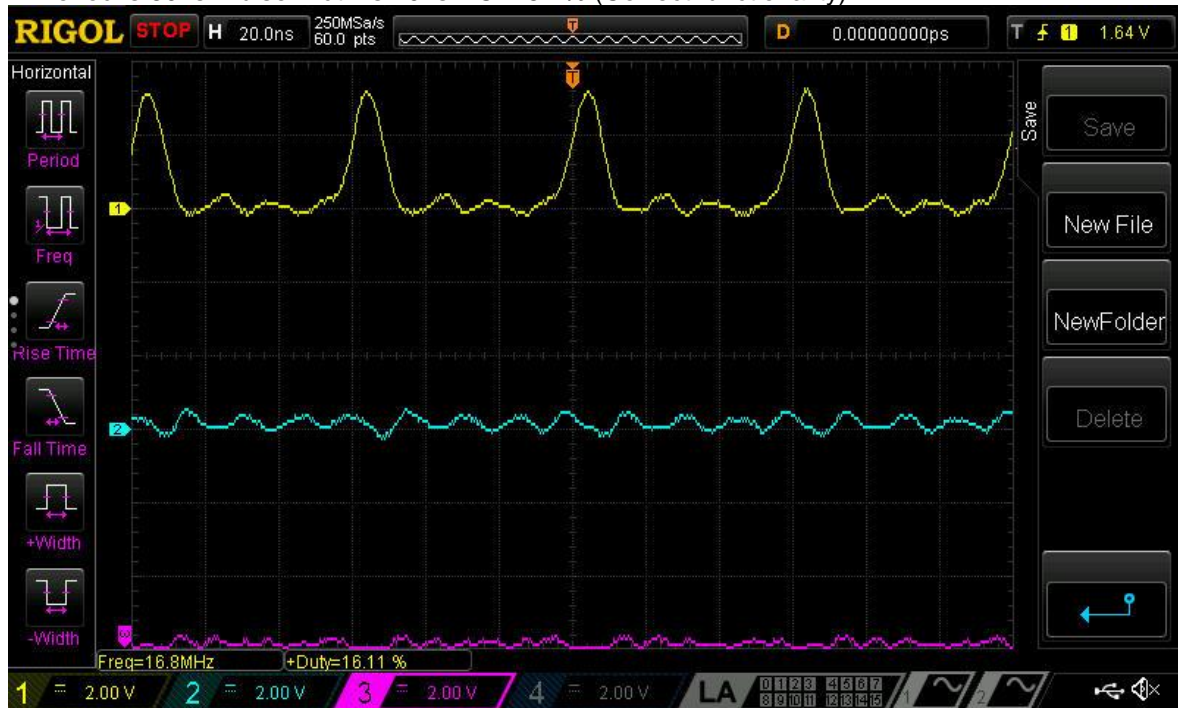
Figure 5

1. Period is 60ns. Pulse width is 10ns DC=16.7% (Correct functionality)

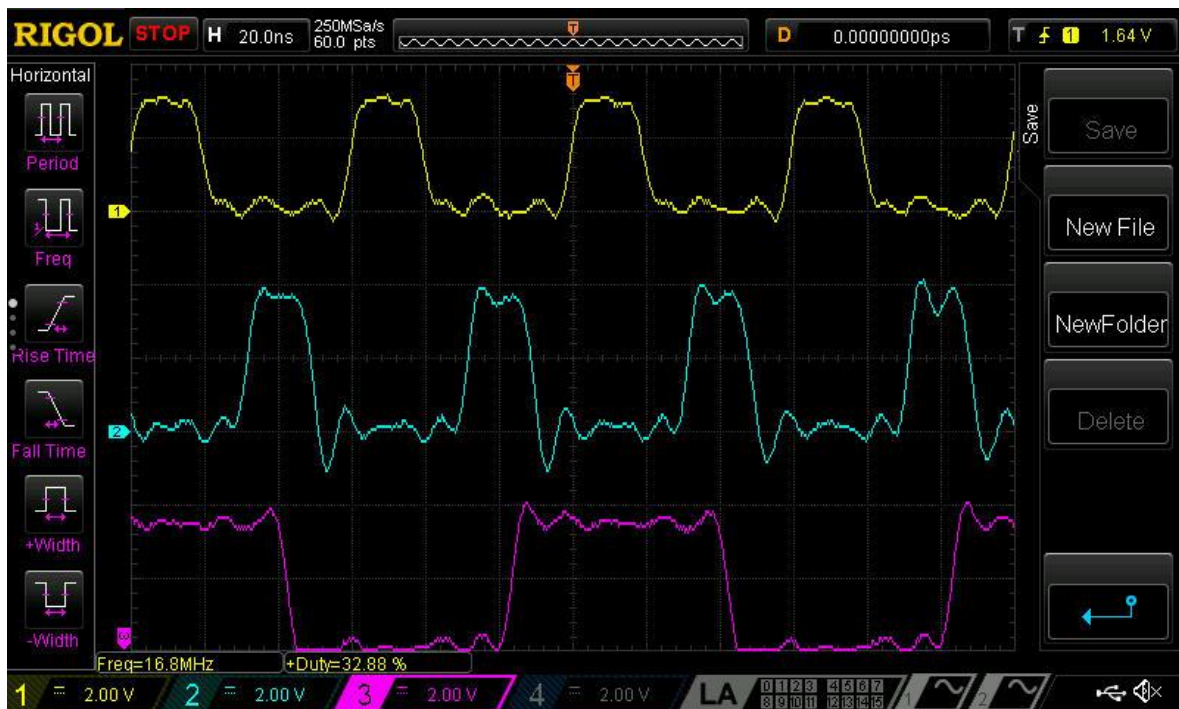
Figure 6

2. Period is 60ns. Pulse width is 20ns DC = 33.3% (Incorrect functionality)

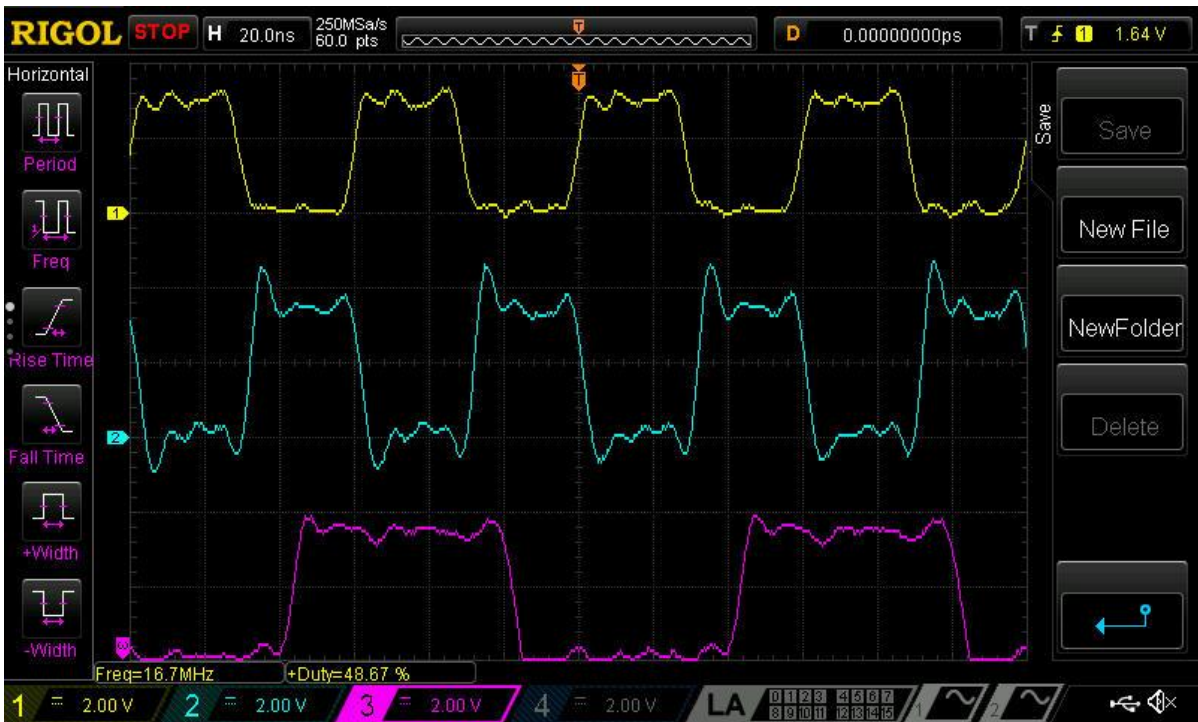
Figure 7

3. Period is 60ns. Pulse width is 30ns DC=50% (Incorrect functionality)

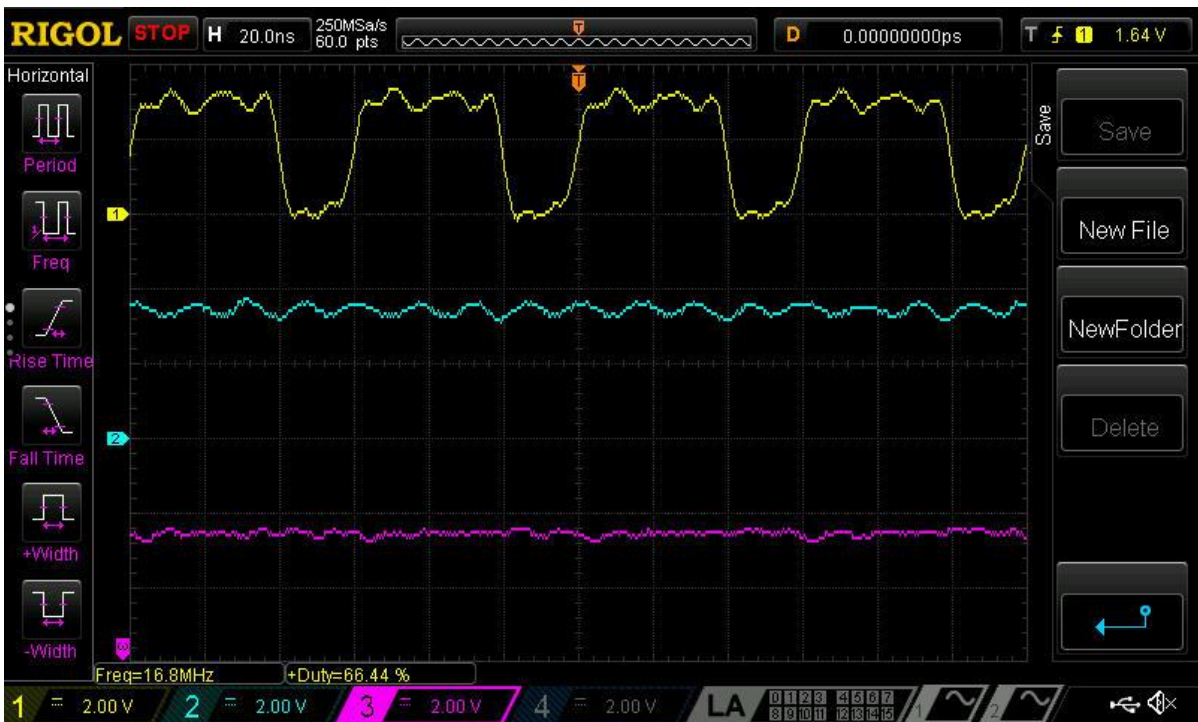
Figure 8

4. Period is 60ns. Pulse width is 40ns DC=66.67% (Correct functionality)

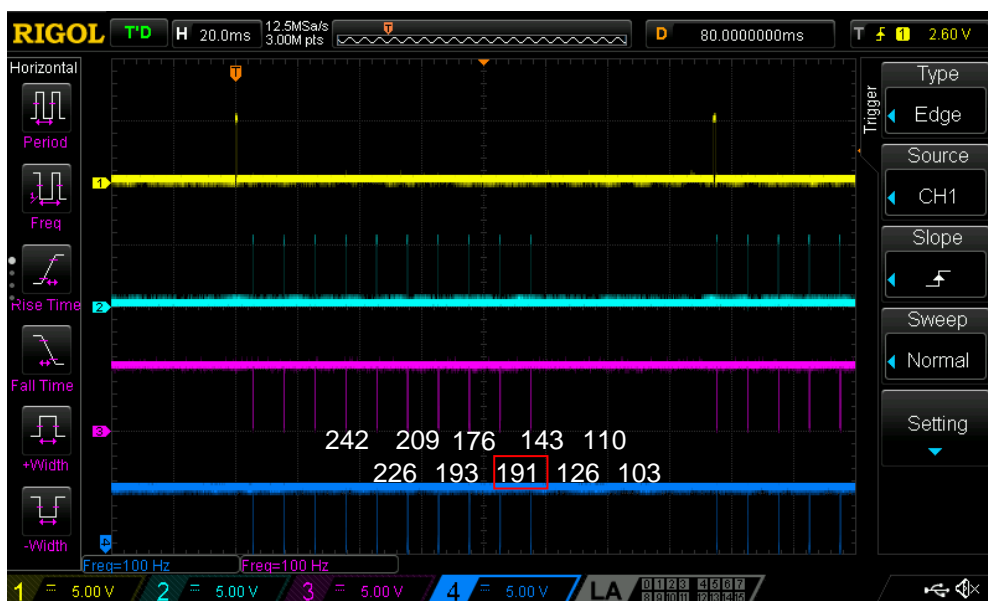
Figure 9

Asynchronous interaction between the CNT/DLY clock input and the I2C latch signal (generated by an I2C read command of the CNT/DLY block's count value) can result in an incorrect I2C data read. The CNT/DLY block will count accurately, but the count value transferred into the block's I2C read register might be loaded incompletely if the I2C latch signal and the clock input occur at about the same time.

The example data capture below shows ten periodic I2C reads of CNT2/DLY2 configured to count down at about 16 clocks per read. The sixth read sample erroneously shows a value greater than that of the fifth. The seventh sample reads as if the previous I2C error never occurred - the difference from the fifth sample (176) to the seventh (143) is 33 clocks or 16 clocks + 17 clocks as expected.

If the possibility of incorrect I2C data reads can't be accommodated for by external software checks, one can guarantee proper operation by stopping the CNT/DLY block's clock during I2C reads through one of the following methods: by disabling the oscillator block, by reconfiguring the CNT/DLY block's clock source, or by gating an external clock using a LUT (Look-up Table) in the signal matrix. After disabling the CNT/DLY block's clock, the count registers can be read without error. Please note that this workaround will add the I2C read and processing time to the counter's overall clock period.

The best workaround depends on the resource constraints of the application. If the oscillator block doesn't clock other logic elements within the design, a matrix output can be used to manually power down the oscillators for the I2C read. When the CNT/DLY block's clock source is routed internally from the oscillator block, I2C commands can temporarily reconfigure the CNT/DLY block's clock source registers to select "Ext. CLK. (From Matrix)." This action will disable the clock by connecting it to ground. If the CNT/DLY block is clocked from the signal matrix, a LUT can be used to gate the clock during an I2C read.

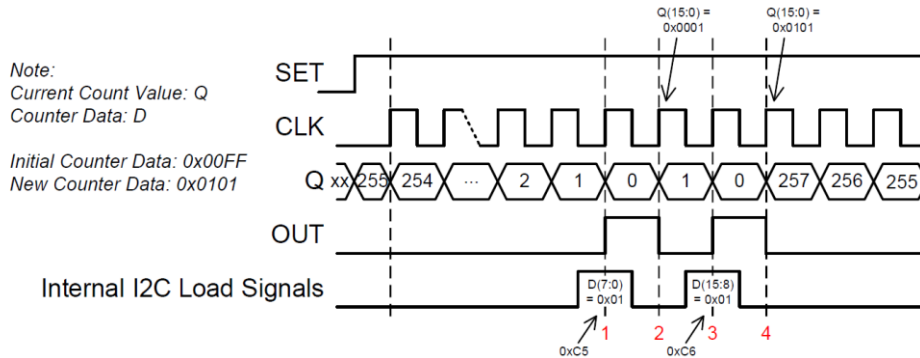
Figure 10: I2C Write of 16-Bit Counter Data Example

The timing diagram in Figure 10 sets up a case where an improper output will be seen on the counter. In this example, the initial Counter Data value (D) is set up as 0x00FF. As you can see, the Current Count Value (Q) decrements from 255 down to 0 with rising edges on CLK. At time “1” denoted by a red number 1, an I2C command (not shown) has just been sent to the GreenPAK device to reconfigure the Counter Data value to 0x0101.

As previously mentioned, the 16-bit value is loaded from the I2C buffers to the Counter Data registers in 8-bit chunks. Right at time “1”, the LSB byte (0x01) is loaded into the Counter Data registers. This makes the Counter Data value temporarily equal to 0x0001. At time “2” between the internal I2C load signals, the counter receives a rising edge on its clock input. This causes the Current Count Value to underflow and to be loaded with the Counter Data value which is 0x0001. At time “3”, the MSB byte (0x01) is loaded into the Counter Data registers setting the Counter Data value to 0x0101. At time “4”, the Current Count Value underflows again and is set to the Counter Data value of 0x0101.

This behavior results in two output pulses on OUT when only one pulse is expected. Observing this behavior depends upon the asynchronous timing between the counter’s clock and the I2C write command to the Counter Data registers. For some applications, the extra pulse on OUT can be ignored and the counter will self-correct after underflowing, overflowing, or being SET/RESET through the GreenPAK connection matrix.

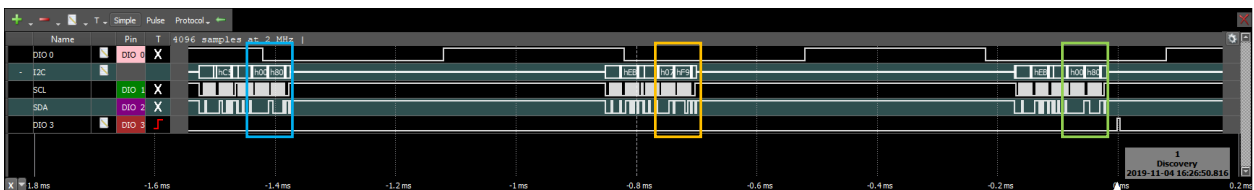
Figure 12: Counter Behavior

For the following condition, the Counter Data register contents are unexpectedly loaded into the counter’s DFF chain. This behavior occurs when there is a falling edge on the counter block’s clock input during the data return portion of an I2C read of the Counter Data registers. Figure 10 shows this falling edge boxed in light blue followed by two I2C reads of the Current Count Value registers.

As you can see by the MCU data log below, the Current Count Value gradually increases from 0xF904 to 0xF907 but is unexpectedly reset to 0x8000. Please note that the colored HEX values in the MCU Log correspond to the boxed I2C read commands shown in the waveform above. As previously described, this reset occurs because there is a falling edge on the counter’s clock input while the GreenPAK device is responding to an I2C read request to 0xC5 and 0xC6. (Note that 0xC5/0xC6 are the Counter Data registers and 0xEB/0xEC are the Current Count Value registers for CNT0.)

The reason that the counter isn’t set to 0x8000 on the I2C read immediately following the Counter Data query is because the counter requires two rising edges on its clock input to load the data from the Counter Data registers into the DFF chain. Note that all rising edges during Tstop will be gated internally by the “Stop and Restart” feature.

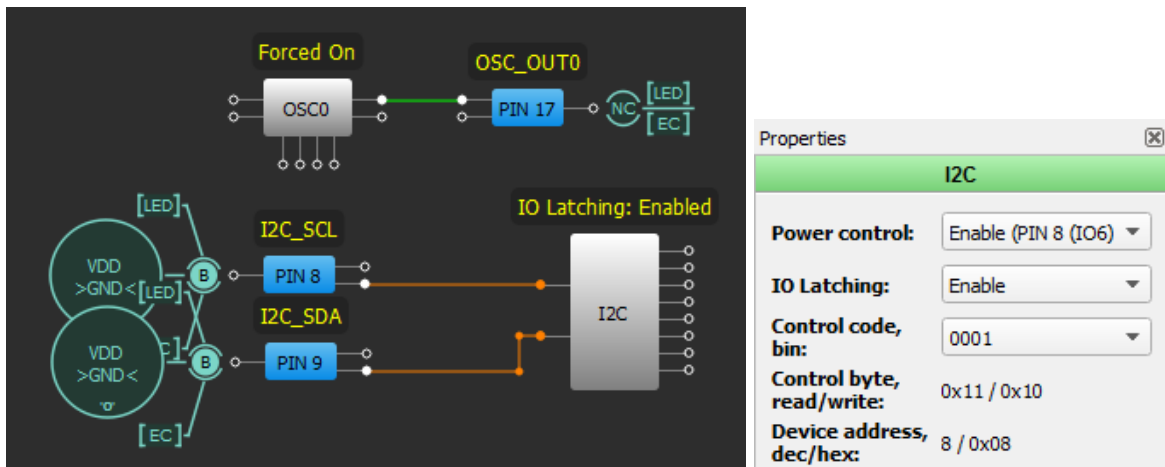
Figure 11

In the example below, we will be monitoring the OSC output, which is measured by a scope on Channel 3 via PIN17 (“OSC_OUT0”). The I2C bus will be forced low to create a START bit.

Disable IO Latching in programmed OTP. This register is I2C-write locked during normal operation and therefore should be disabled in configuration file.
 Do not share I2C bus with other devices and make sure the I2C bus is not powered down while the GreenPAK is still powered through VDD.

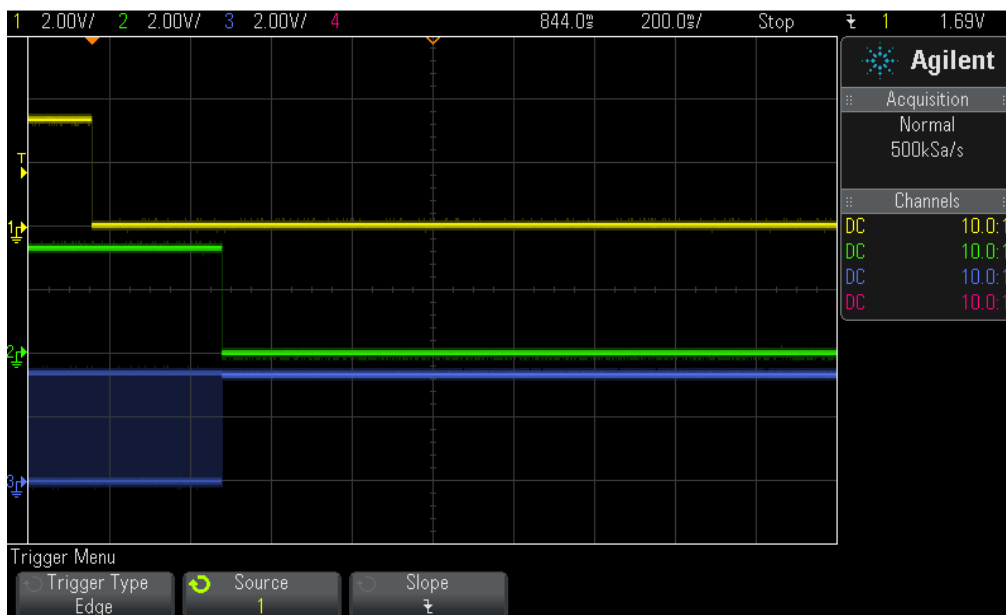
Figure 12

By toggling I2C_SDA low and then I2C_SCL low, the GreenPAK registers this as a start bit and latches all General Purpose Outputs such as PIN#17(“OSC_OUT0”). In the Figure 12, notice that PIN#17 (OSC_OUT0) stops toggling.
