# Errata

## SLG4653x

### CE-GP-002

*This document contains the known errata for SLG46533, SLG46534, SLG46535, SLG46536, SLG46537, SLG46538 and the recommended workarounds.*

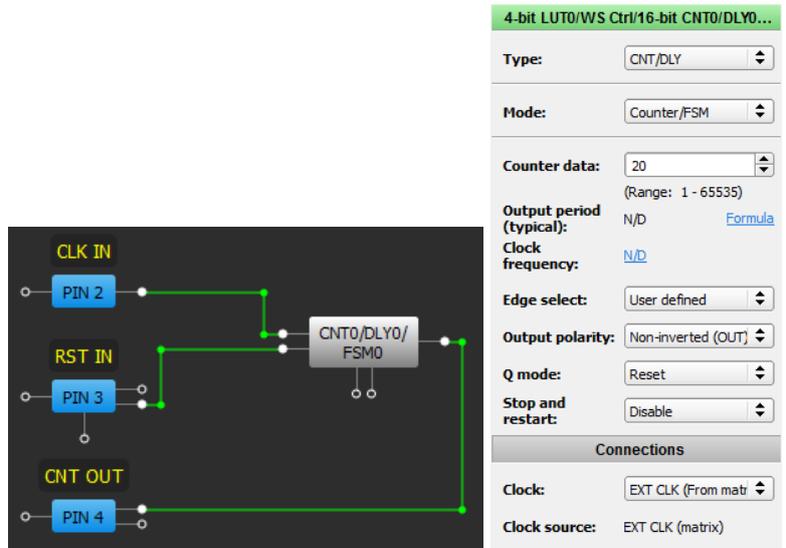
Figure 1

If the Counter Reset is asserted at the same time as a rising clock edge, it is possible that the Counter Data will be reset incorrectly and the counter output may appear faster than expected. This phenomenon appears more often as the clock frequency increases.

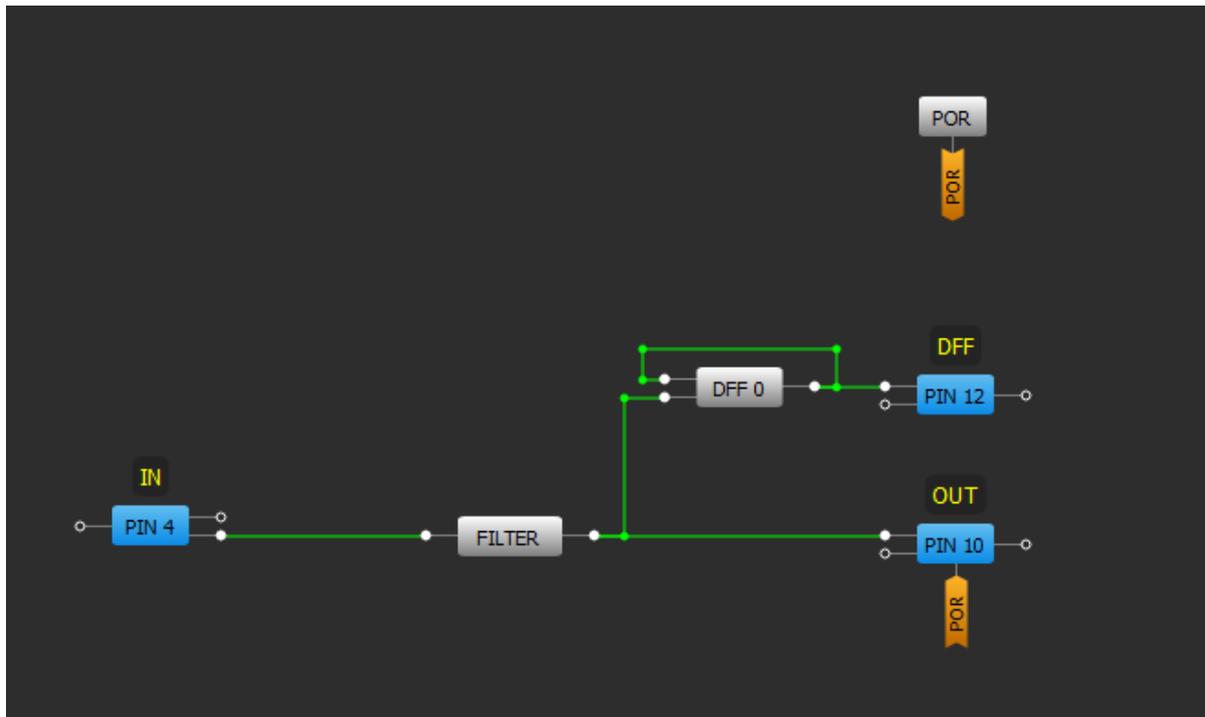
Figure 4

If clock type high frequency input comes in, the FILTER cell may not filter out it. There are several factors like input frequency, duty cycle and LOW duration in such signal that may lead to its passing through FILTER block.

Currently there is no workaround for this issue. Filter block is good at filtering short spontaneous glitches. It is intended to be used in series connection before the delay cell to avoid its latching.

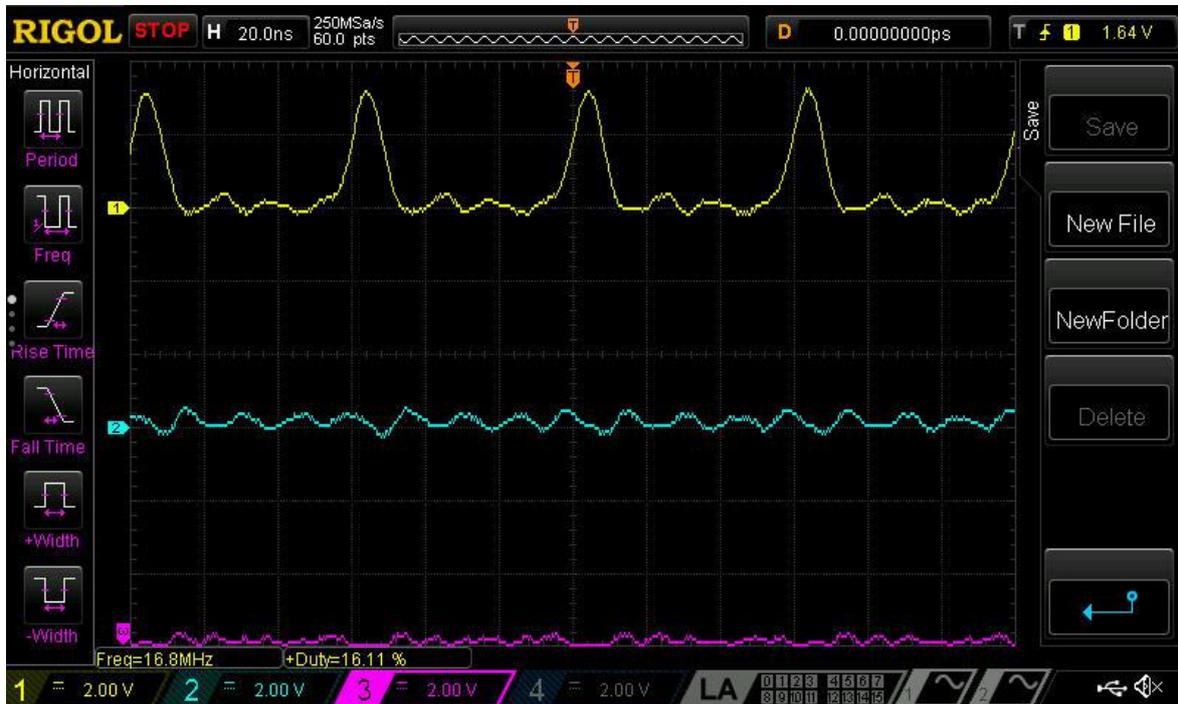
Figure 5

1. Period is 60ns. Pulse width is 10ns DC=16.7% (Correct functionality)

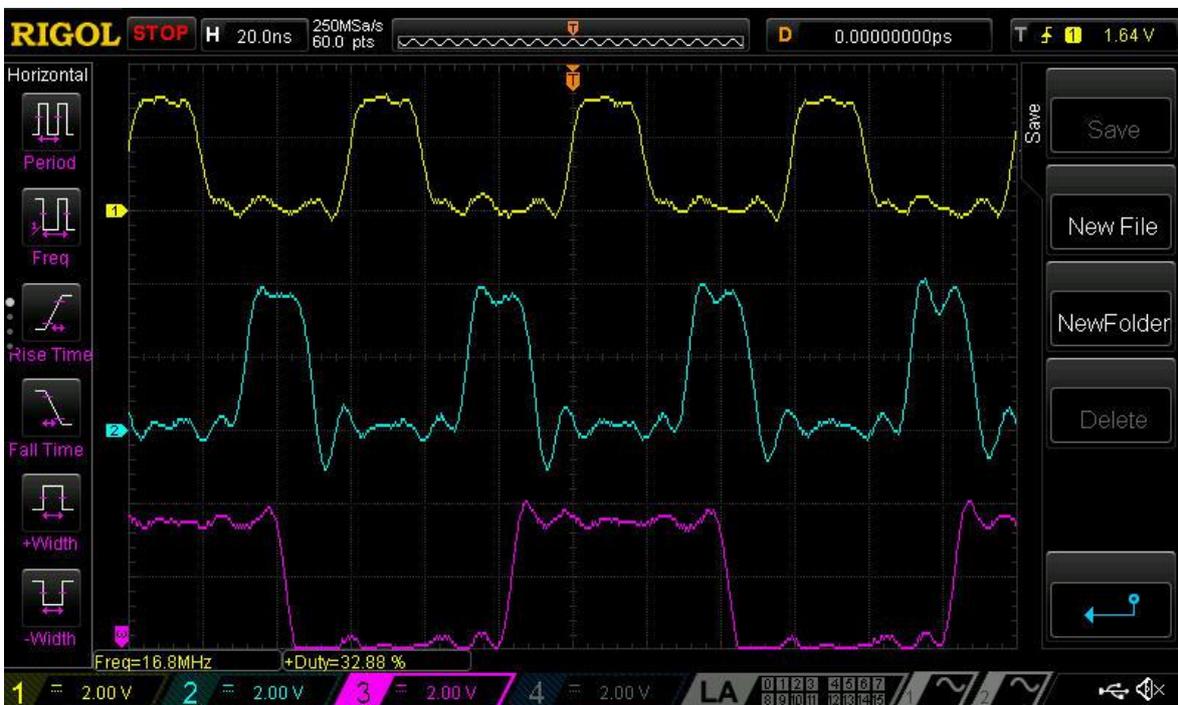
Figure 6

2. Period is 60ns. Pulse width is 20ns DC = 33.3% (Incorrect functionality)

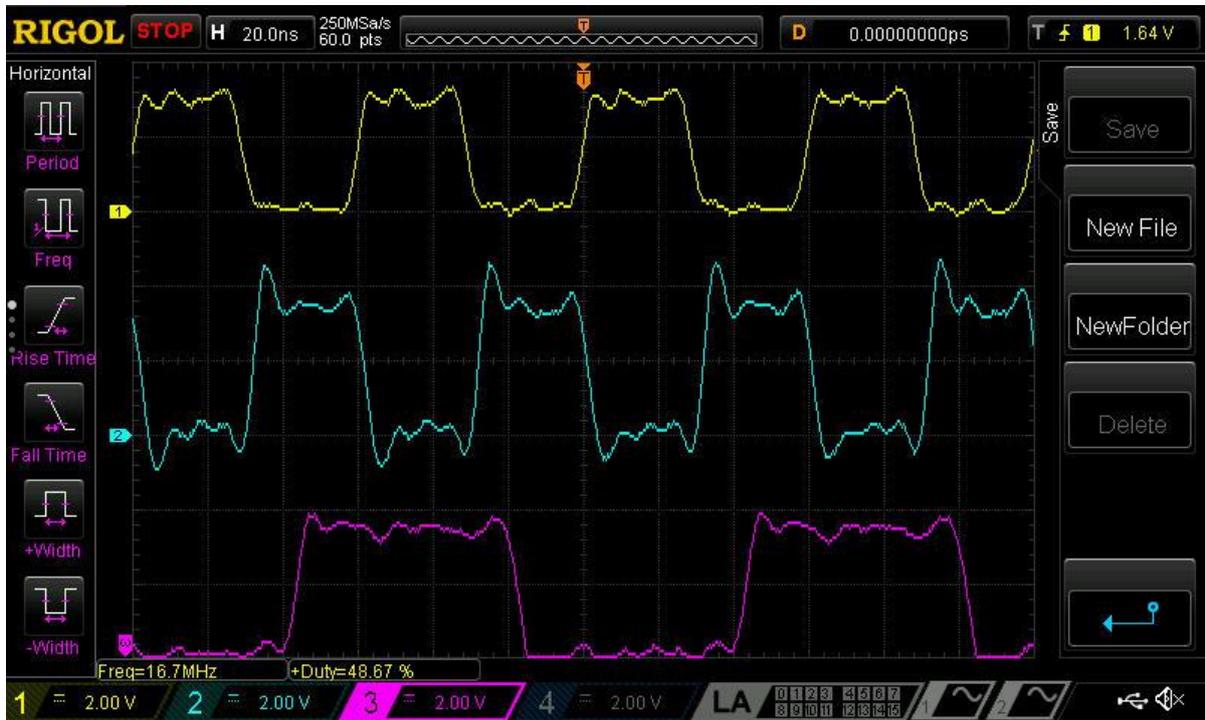
Figure 7

3. Period is 60ns. Pulse width is 30ns DC=50% (Incorrect functionality)

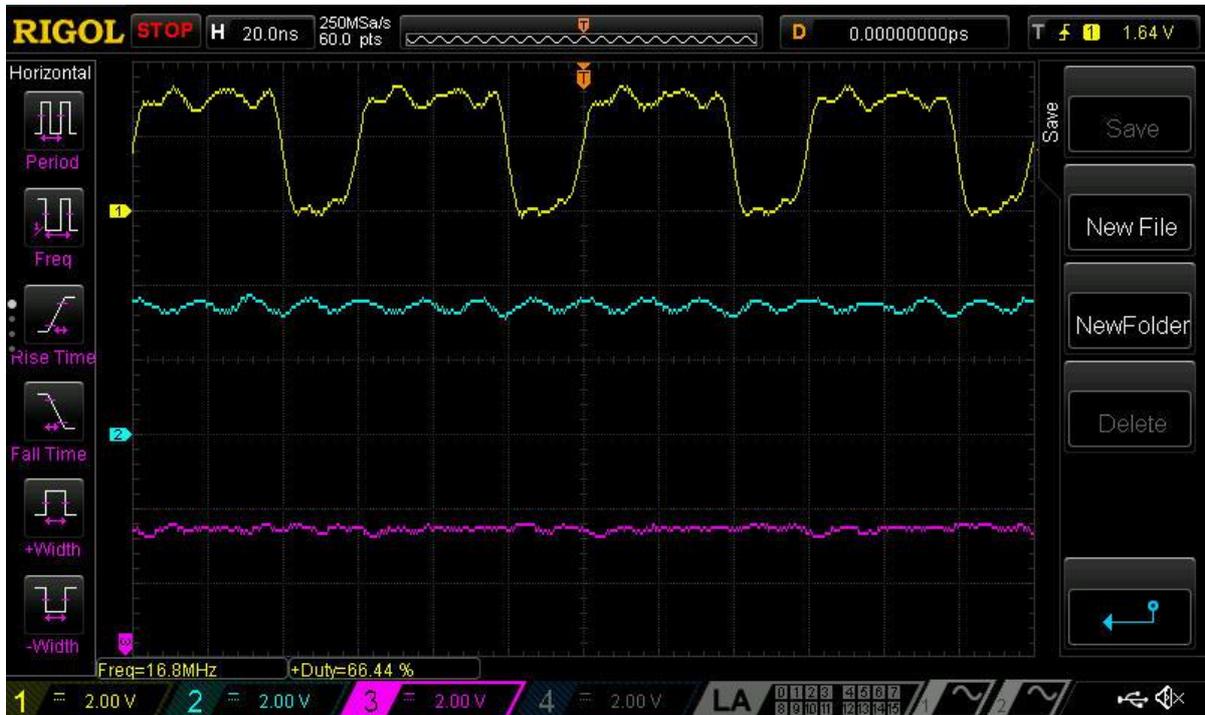
Figure 8

4. Period is 60ns. Pulse width is 40ns DC=66.67% (Correct functionality)

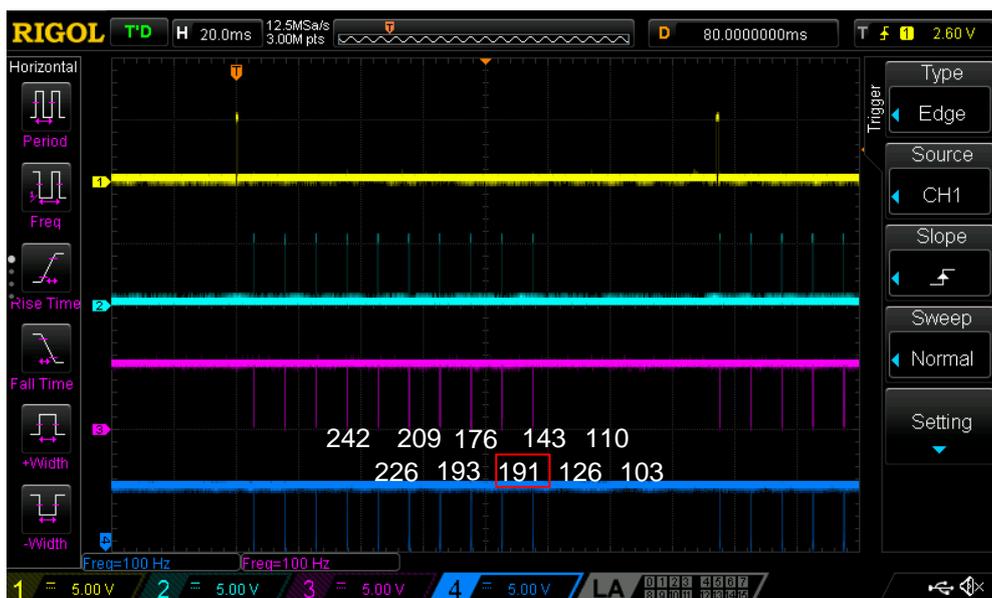
Figure 9

Asynchronous interaction between the CNT/DLY clock input and the I2C latch signal (generated by an I2C read command of the CNT/DLY block's count value) can result in an incorrect I2C data read. The CNT/DLY block will count accurately, but the count value transferred into the block's I2C read register might be loaded incompletely if the I2C latch signal and the clock input occur at about the same time.

The example data capture below shows ten periodic I2C reads of CNT2/DLY2 configured to count down at about 16 clocks per read. The sixth read sample erroneously shows a value greater than that of the fifth. The seventh sample reads as if the previous I2C error never occurred - the difference from the fifth sample (176) to the seventh (143) is 33 clocks or 16 clocks + 17 clocks as expected.

If the possibility of incorrect I2C data reads can't be accommodated for by external software checks, one can guarantee proper operation by stopping the CNT/DLY block's clock during I2C reads through one of the following methods: by disabling the oscillator block, by reconfiguring the CNT/DLY block's clock source, or by gating an external clock using a LUT (Look-up Table) in the signal matrix. After disabling the CNT/DLY block's clock, the count registers can be read without error. Please note that this workaround will add the I2C read and processing time to the counter's overall clock period.

The best workaround depends on the resource constraints of the application. If the oscillator block doesn't clock other logic elements within the design, a matrix output can be used to manually power down the oscillators for the I2C read. When the CNT/DLY block's clock source is routed internally from the oscillator block, I2C commands can temporarily reconfigure the CNT/DLY block's clock source registers to select "Ext. CLK. (From Matrix)." This action will disable the clock by connecting it to ground. If the CNT/DLY block is clocked from the signal matrix, a LUT can be used to gate the clock during an I2C read.

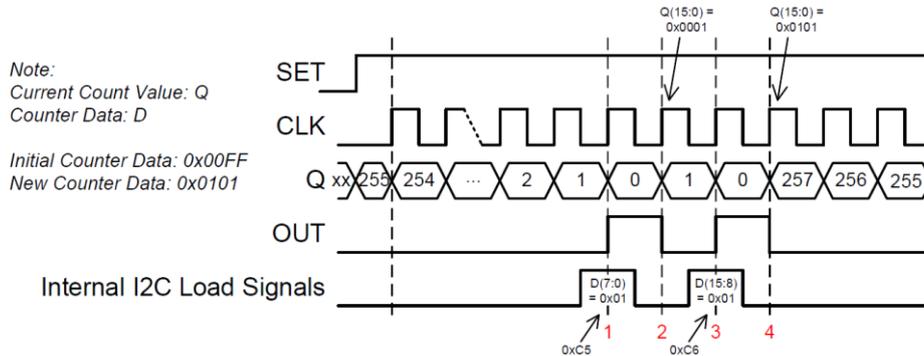
The timing diagram in Figure 10 sets up a case where an improper output will be seen on the counter. In this example, the initial Counter Data value (D) is set up as 0x00FF. As you can see, the Current Count Value (Q) decrements from 255 down to 0 with rising edges on CLK. At time “1” denoted by a red number 1, an I2C command (not shown) has just been sent to the GreenPAK device to reconfigure the Counter Data value to 0x0101.

Figure 10: I2C Write of 16-Bit Counter Data Example

As previously mentioned, the 16-bit value is loaded from the I2C buffers to the Counter Data registers in 8-bit chunks. Right at time “1”, the LSB byte (0x01) is loaded into the Counter Data registers. This makes the Counter Data value temporarily equal to 0x0001. At time “2” between the internal I2C load signals, the counter receives a rising edge on its clock input. This causes the Current Count Value to underflow and to be loaded with the Counter Data value which is 0x0001. At time “3”, the MSB byte (0x01) is loaded into the Counter Data registers setting the Counter Data value to 0x0101. At time “4”, the Current Count Value underflows again and is set to the Counter Data value of 0x0101.

This behavior results in two output pulses on OUT when only one pulse is expected. Observing this behavior depends upon the asynchronous timing between the counter’s clock and the I2C write command to the Counter Data registers. For some applications, the extra pulse on OUT can be ignored and the counter will self-correct after underflowing, overflowing, or being SET/RESET through the GreenPAK connection matrix.

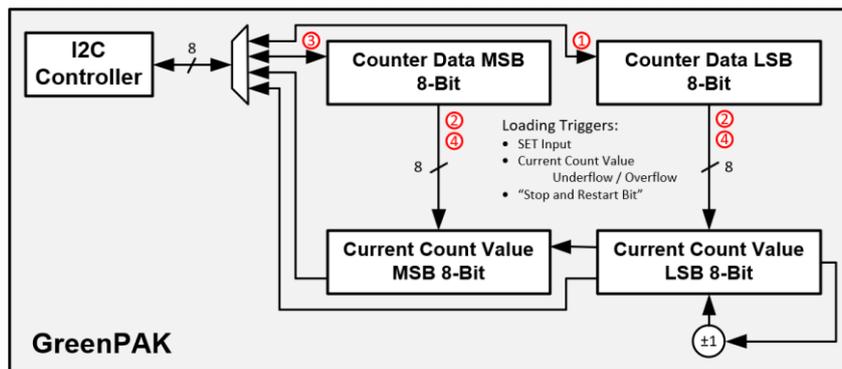
Figure 11: 16-Bit I2C Counter Block Diagram

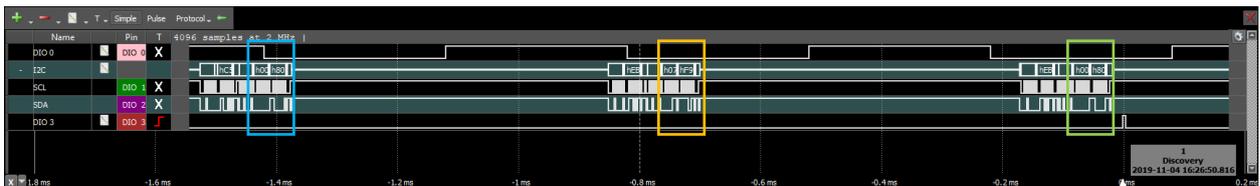
For the following condition, the Counter Data register contents are unexpectedly loaded into the counter’s DFF chain. This behavior occurs when there is a falling edge on the counter block’s clock input during the data return portion of an I2C read of the Counter Data registers. Figure 10 shows this falling edge boxed in light blue followed by two I2C reads of the Current Count Value registers.

Figure 12: Counter Behavior

As you can see by the MCU data log below, the Current Count Value gradually increases from 0xF904 to 0xF907 but is unexpectedly reset to 0x8000. Please note that the colored HEX values in the MCU Log correspond to the boxed I2C read commands shown in the waveform above. As previously described, this reset occurs because there is a falling edge on the counter’s clock input while the GreenPAK device is responding to an I2C read request to 0xC5 and 0xC6. (Note that 0xC5/0xC6 are the Counter Data registers and 0xEB/0xEC are the Current Count Value registers for CNT0.)

The reason that the counter isn’t set to 0x8000 on the I2C read immediately following the Counter Data query is because the counter requires two rising edges on its clock input to load the data from the Counter Data registers into the DFF chain. Note that all rising edges during Tstop will be gated internally by the “Stop and Restart” feature.

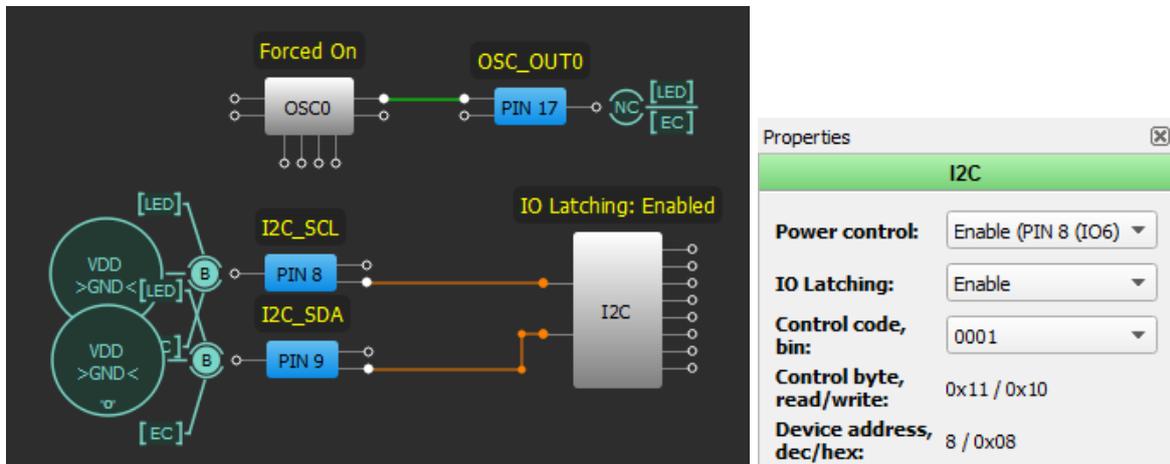
Figure 11

In the example below, we will be monitoring the OSC output, which is measured by a scope on Channel 3 via PIN17 (“OSC\_OUT0”). The I2C bus will be forced low to create a START bit.

Disable IO Latching in programmed OTP. This register is I2C-write locked during normal operation and therefore should be disabled in configuration file.  
 Do not share I2C bus with other devices and make sure the I2C bus is not powered down while the GreenPAK is still powered through VDD.

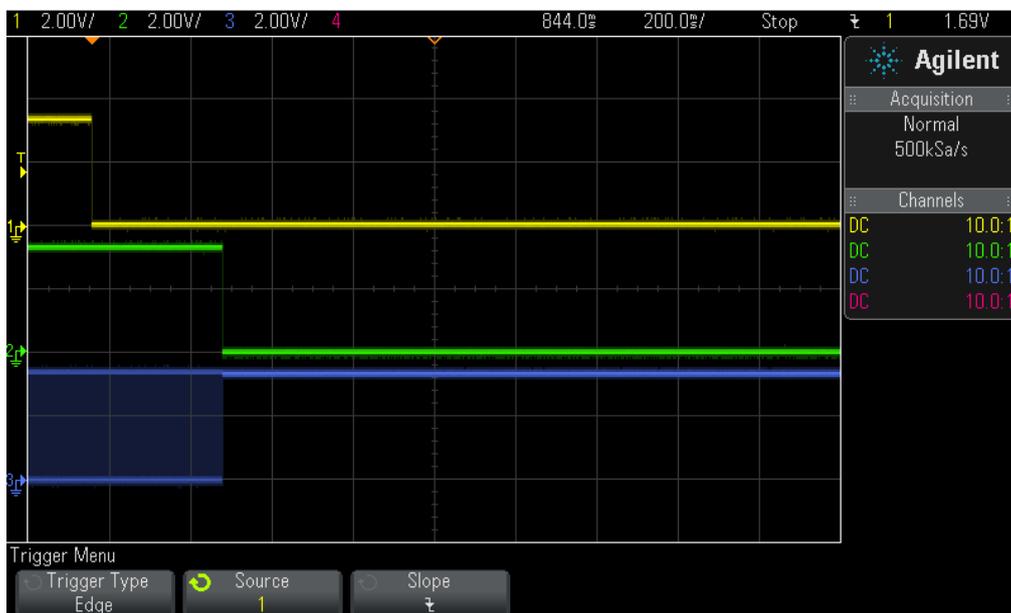
Figure 12

By toggling I2C\_SDA low and then I2C\_SCL low, the GreenPAK registers this as a start bit and latches all General Purpose Outputs such as PIN#17(“OSC\_OUT0”). In the Figure 12, notice that PIN#17 (OSC\_OUT0) stops toggling.
