SLG46580

ISSUE 1: Long 2 MHz OSC Settling Time

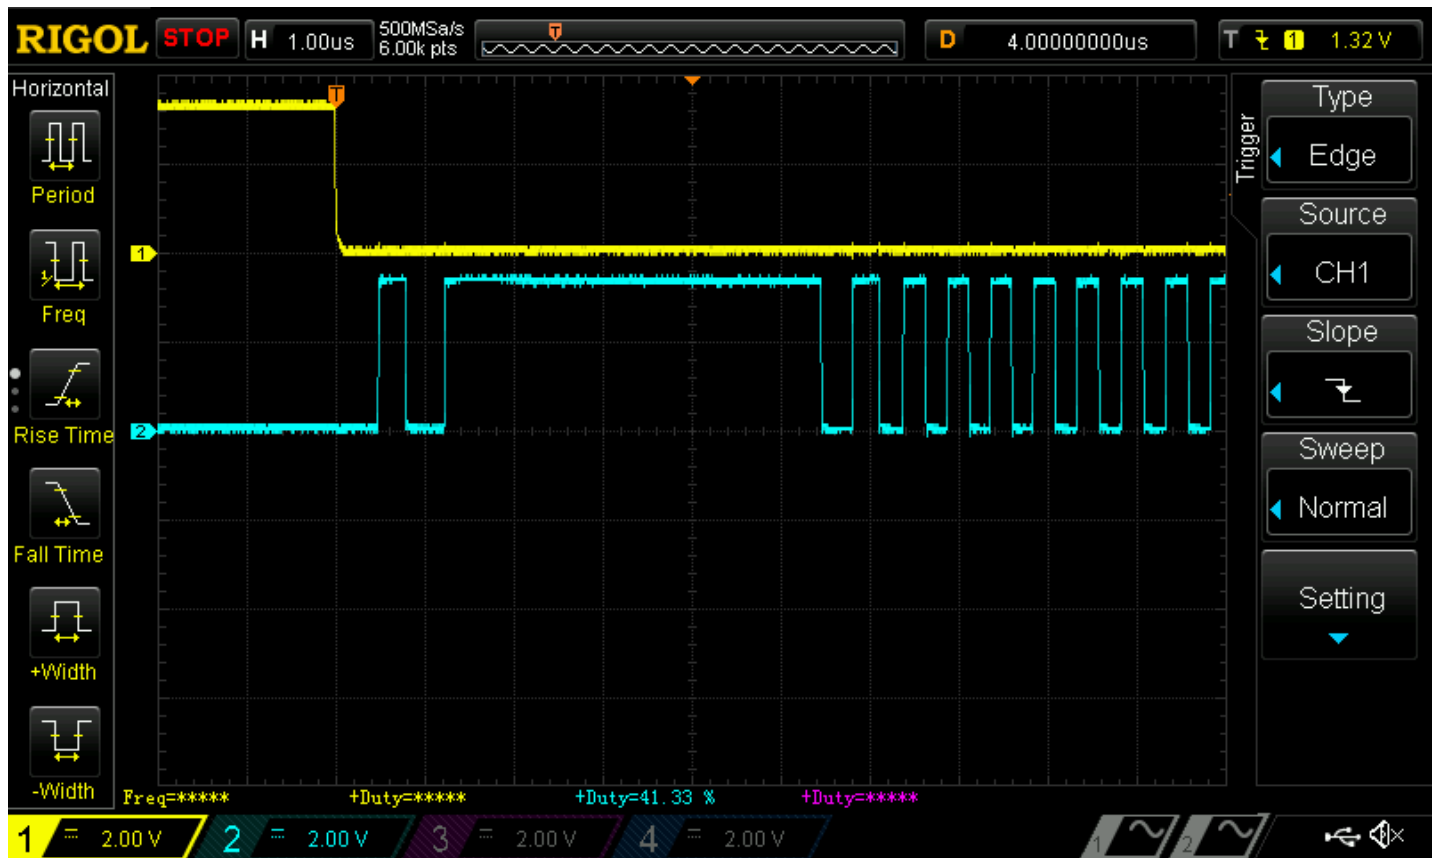
2MHz OSC has an additional ~ 9 cycles settling period. Higher VDD shows longer settling time.

Channel 1 – OSC Power Down; Channel 2 –OSC output

Such behavior will lead to substantial error in period calculations if the delay time is relatively small.

- Enable Fast Start-up option. Fast Start-up means forcing bias ready at the power-up instead of automatic enabling at OSC event. The standby current consumption difference between Fast start-up disabled and enabled is only an additional 300 nA.
- Use the “Force power on” OSC power control option to make the OSC operate at all times. However, this will cause increased constant current consumption.

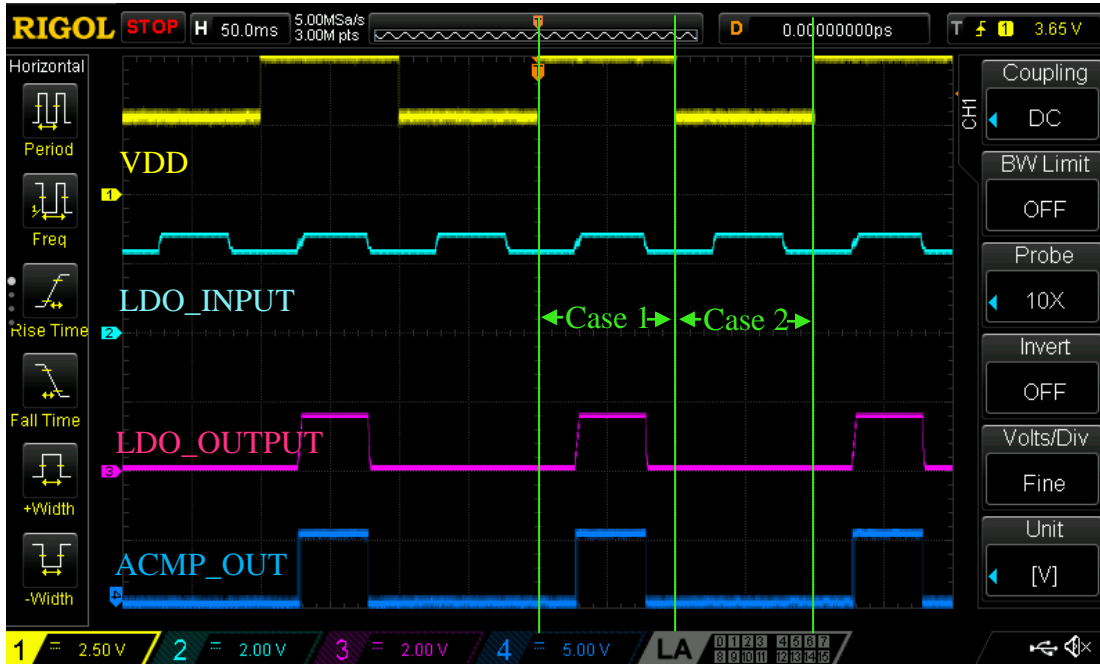
Case 1: Proper Behavior at VDD = 5V;

With a 5V VDD, the NMOS transmission gate passes the 2.25 and 2.75V LDO_INPUT pin voltages to the ACMP's IN+ port. When the input voltage exceeds the 2.4V IN- threshold of the ACMP, the LDO is enabled.

Case 2: Erroneous Behavior at VDD = 2.75V;

When the VDD is reduced to 2.75V, the NMOS transmission gate is unable to pass LDO_INPUT's full magnitude to the ACMP's IN+ port. Since the IN+ port of the ACMP doesn't exceed the 2.4V IN- threshold, the ACMP's output stays low and keeps the LDO disabled.

- If the GreenPAK's VDD is always powered up before the LDO's VIN input, you can externally short the LDO's VIN to another dedicated analog input pin for the desired ACMP.

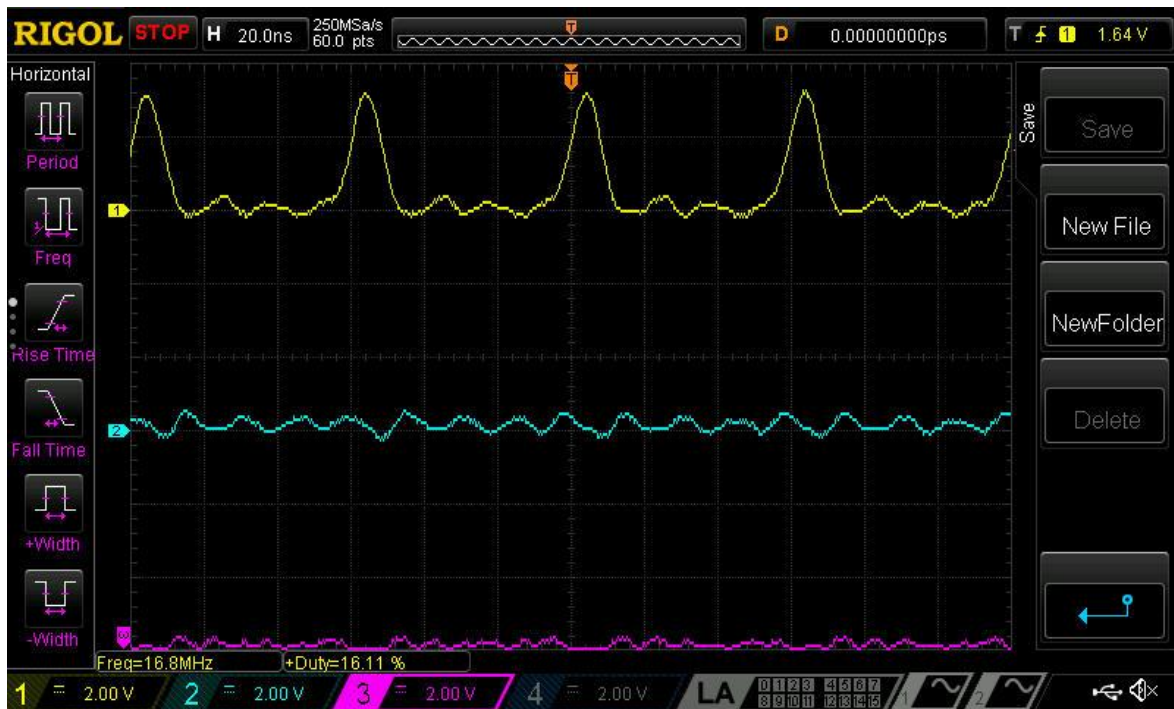
Channel 1 (yellow/top line) – PIN#4 (IN)
 Channel 2 (light blue/2nd line) – PIN#10 (OUT)
 Channel 3 (magenta /3rd line) – PIN#12 (DFF)

1. Period is 60ns. Pulse width is 10ns DC=16.7% (Correct functionality)

Currently, there is no workaround for this issue. The FILTER block correctly filters isolated glitches, but it shouldn't be used to filter repetitive, high frequency input signals.

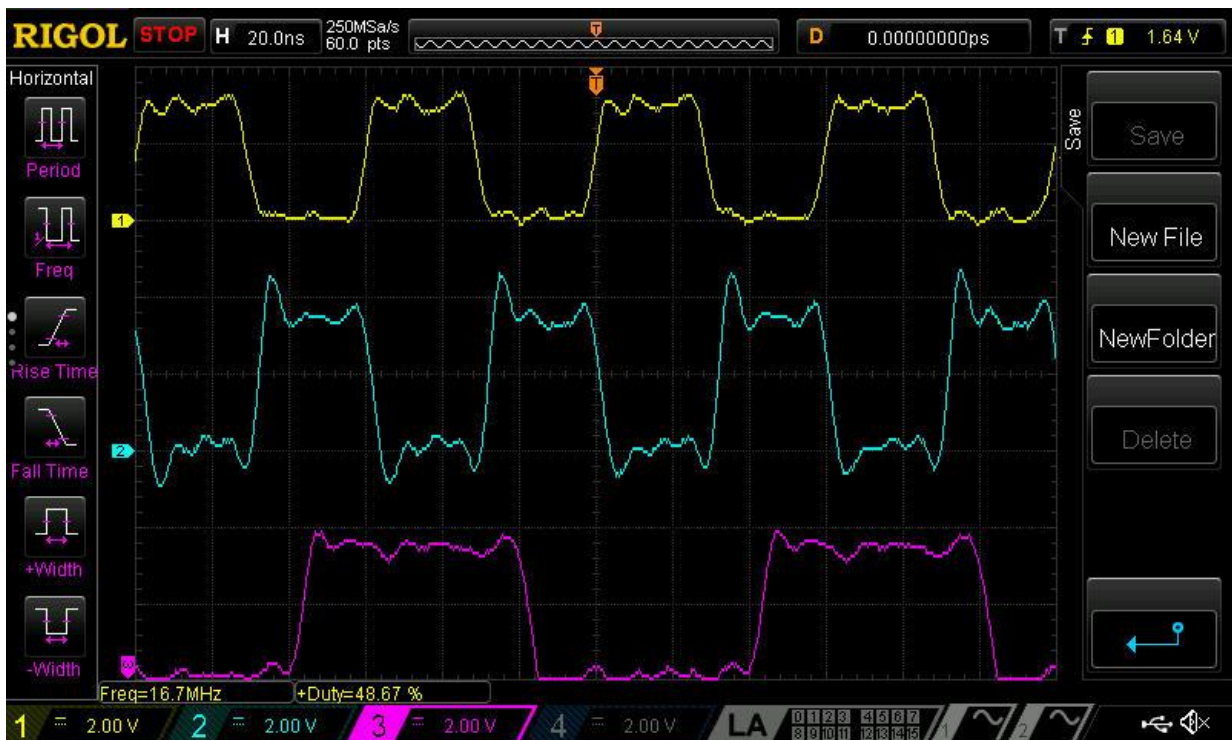
If the FILTER cell's input signal contains multiple consecutive pulses within short time intervals, the FILTER cell may not filter the input pulses as expected. The errant behavior applies only to repeated input pulses and depends on both their frequency and duty cycle.

3. Period is 60ns. Pulse width is 30ns DC=50% (Incorrect functionality)

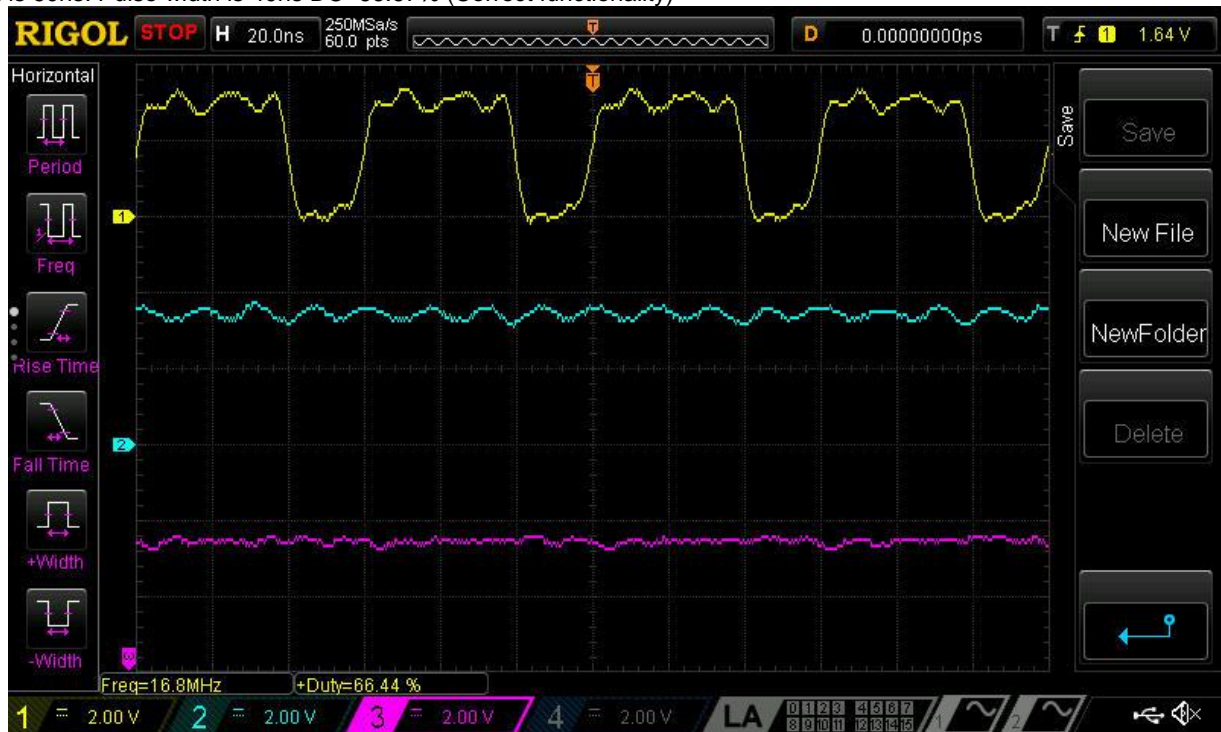
4. Period is 60ns. Pulse width is 40ns DC=66.67% (Correct functionality)

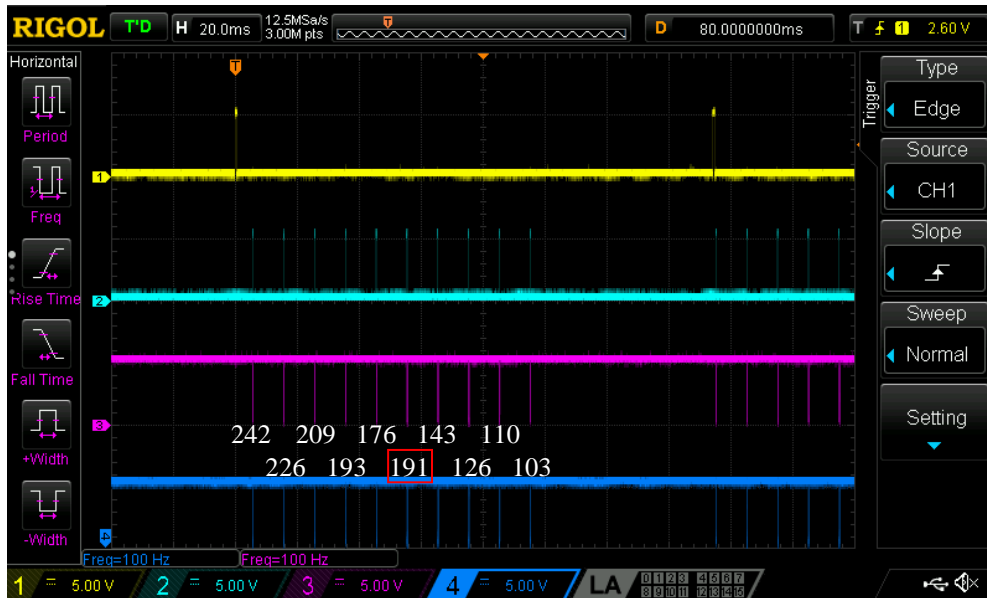
Asynchronous interaction between the CNT/DLY clock input and the I²C latch signal (generated by an I²C read command of the CNT/DLY block's count value) can result in an incorrect I²C data read. The CNT/DLY block will count accurately, but the count value transferred into the block's I²C read register might be loaded incompletely if the I²C latch signal and the clock input occur at about the same time.

The example data capture below shows ten periodic I²C reads of CNT2/DLY2 configured to count down at about 16 clocks per read. The sixth read sample erroneously shows a value greater than that of the fifth. The seventh sample reads as if the previous I²C error never occurred - the difference from the fifth sample (176) to the seventh (143) is 33 clocks or 16 clocks + 17 clocks as expected.

Channel 1 (yellow/top line) – PIN#2 (CNT2/DLY2 Out)
 Channel 2 (light blue/2nd line) – PIN#1 (I²C Read Triggers)
 Channel 3 (magenta /3rd line) – PIN#8 (I²C SCL)
 Channel 3 (dark blue /4th line) – PIN#9 (I²C SDA)

If the possibility of incorrect I²C data reads can't be accommodated for by external software checks, one can guarantee proper operation by stopping the CNT/DLY block's clock during I²C reads through one of the following methods: by disabling the oscillator block, by reconfiguring the CNT/DLY block's clock source, or by gating an external clock using a LUT (Look-up Table) in the signal matrix. After disabling the CNT/DLY block's clock, the count registers can be read without error. Please note that this workaround will add the I²C read and processing time to the counter's overall clock period.

The best workaround depends on the resource constraints of the application. If the oscillator block doesn't clock other logic elements within the design, a matrix output can be used to manually power down the oscillators for the I²C read. When the CNT/DLY block's clock source is routed internally from the oscillator block, I²C commands can temporarily reconfigure the CNT/DLY block's clock source registers to select "Ext. CLK. (From Matrix)." This action will disable the clock by connecting it to ground. If the CNT/DLY block is clocked from the signal matrix, a LUT can be used to gate the clock during an I²C read.

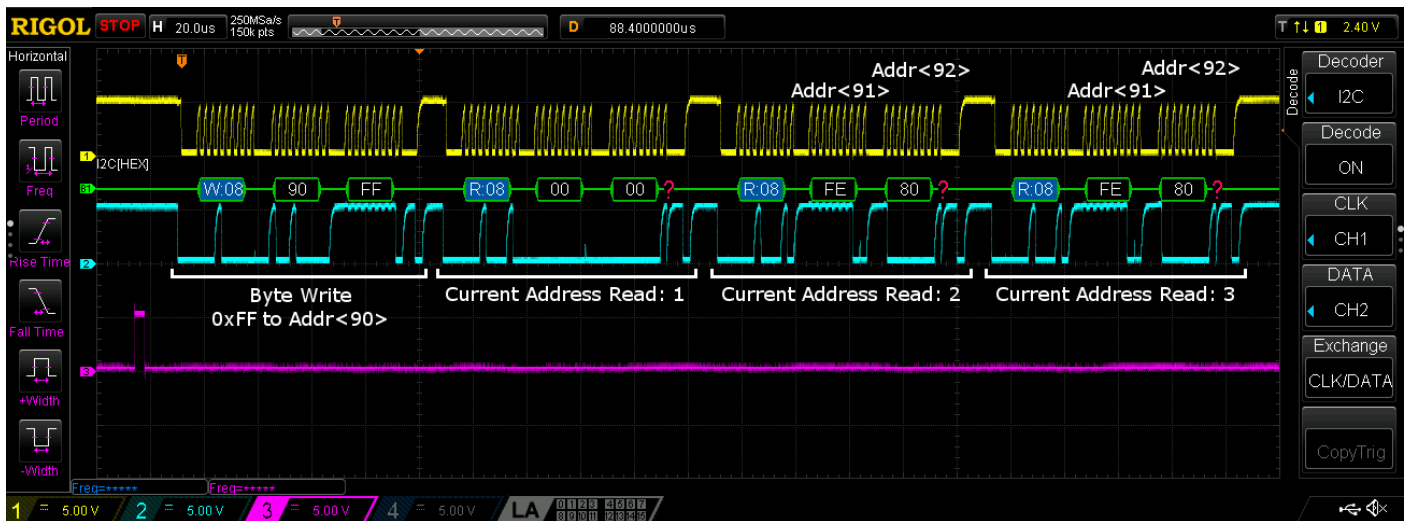
The first “Current Address Read” or “Sequential Read” command following an I²C “Byte Write” or a “Sequential Write” command will produce incorrect data. Additional read commands will return the expected data. See the waveform below for more information.

Channel 1 (yellow/top line) – PIN#8 (SCL)

Channel 2 (light blue/2nd line) – PIN#9 (SDA)

Channel 3 (magenta /3rd line) – I2C Software Trigger

Note: In the GreenPAK test design, Addr<91> and Addr<92> expect FE and 80 respectively.

If possible, use the “Random Read” command as described in the datasheet for SLG46580. This command will output the correct data.

If you expect consecutive reads of the same register, we recommend sending a “Random Read” command to the register preceding the register of interest. After the “Random Read” command finishes, the chip’s register pointer will increment to the desired register and the following “Current Address Read” or “Sequential Read” commands will produce the correct data. Note that the “Current Address Read” and “Sequential Read” commands don’t increment the GreenPAK’s register pointer.
