Errata

SLG46517

CE-GP-001

This document contains the known errata for SLG46517 and the recommended workarounds.

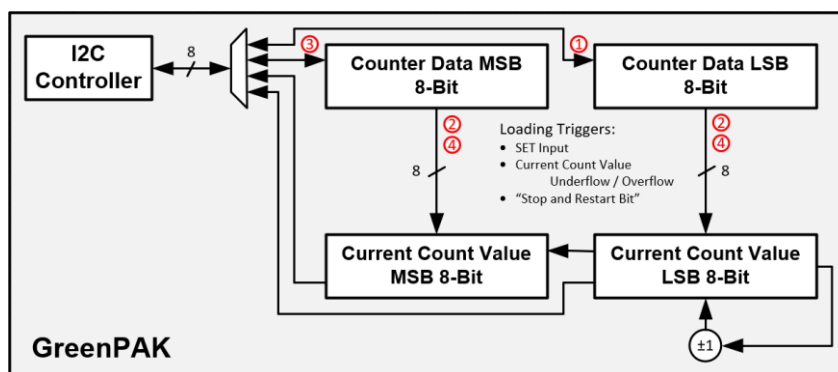
Figure 11: 16-Bit I2C Counter Block Diagram

As previously mentioned, the 16-bit value is loaded from the I2C buffers to the Counter Data registers in 8-bit chunks. Right at time “1”, the LSB byte (0x01) is loaded into the Counter Data registers. This makes the Counter Data value temporarily equal to 0x0001. At time “2” between the internal I2C load signals, the counter receives a rising edge on its clock input. This causes the Current Count Value to underflow and to be loaded with the Counter Data value which is 0x0001. At time “3”, the MSB byte (0x01) is loaded into the Counter Data registers setting the Counter Data value to 0x0101. At time “4”, the Current Count Value underflows again and is set to the Counter Data value of 0x0101.

This behavior results in two output pulses on OUT when only one pulse is expected. Observing this behavior depends upon the asynchronous timing between the counter’s clock and the I2C write command to the Counter Data registers. For some applications, the extra pulse on OUT can be ignored and the counter will self-correct after underflowing, overflowing, or being SET/RESET through the GreenPAK connection matrix.

Within the MCU, we recommend saving the Counter Data register configuration as a software variable so that the Counter Data register doesn’t need to be read during counter operation.
