SLG46580

ISSUE 1: Long 2 MHz OSC Settling Time

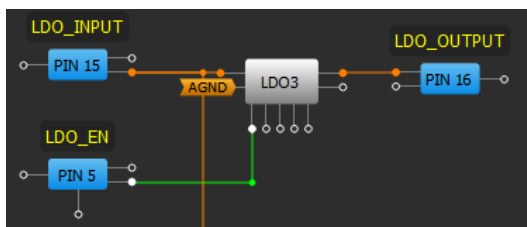
VDD = 5.5V, LDO_INPUT = 5.5V, All other LDOs Disabled

When a GreenPAK's first LDO is enabled, the LDO's VOUT will step to a non-zero voltage during its 500 μ s wait time. The magnitude of this step is directly proportional to the LDO's VIN and the GreenPAK's VDD. With a large LDO input voltage and VDD, this step can exceed 500mV.
